SILVER SPORT

Transmissions

Special A41 Tunnel Rework for 1964-1967 El Camino/Chevelle

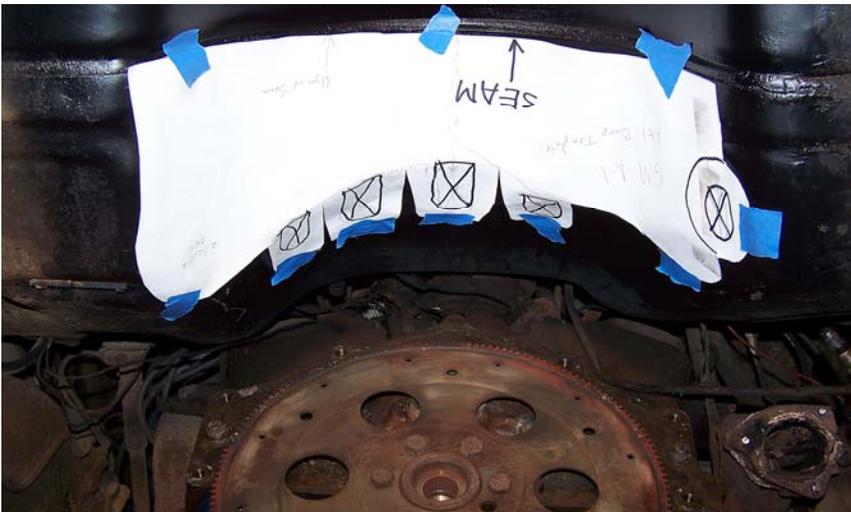
The following picture shows the tunnel with transmission removed. The paper template has been taped to the tunnel aligned with centerline of tunnel and along the body weld seam as shown. The "X" areas are the primary targeted spots for hammering.

Using a paint marker, outline the template that has been taped in place on the tunnel. Using a ball peen hammer or similar tool, strike the tunnel area to bump the "X" areas. It will require several hits to bump the tunnel sheet metal in small increments until the original tunnel has been moved approximately 1/2 to 1".

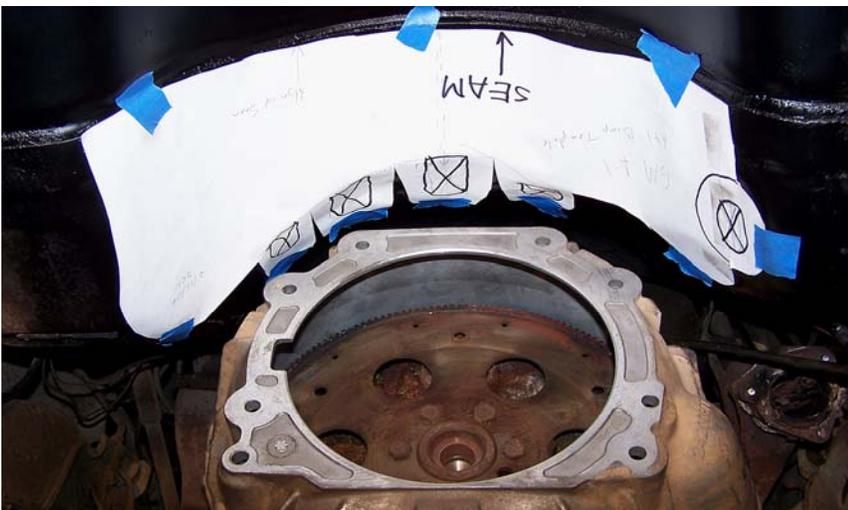
The next picture shows the A41 bell housing installed and illustrates the flange bolt boss areas that are the problem points that create interference.

Note: Do NOT remove bell housing from your A41. Picture is shown for illustrative purposes only.

Due to the removeable bell housing of the A41, the A41 exterior is larger than the original integral bell housing case design for which the tunnel was designed to fit.

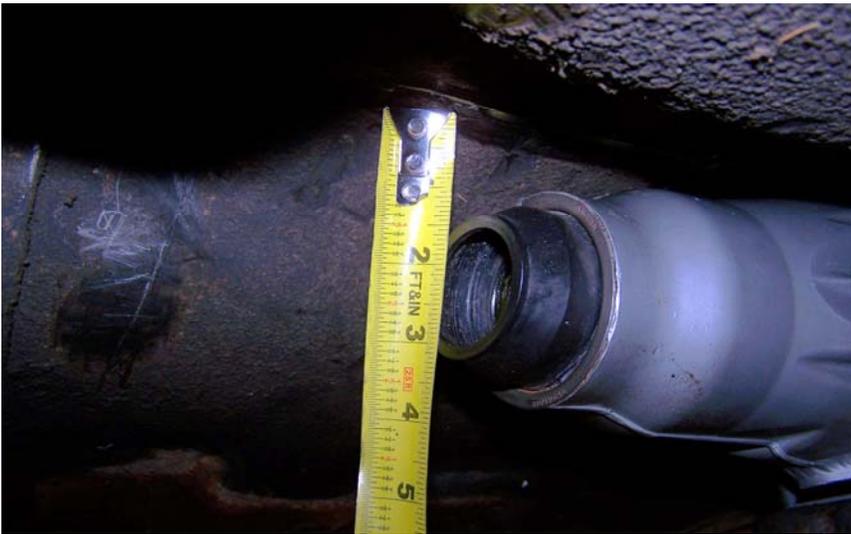
For ease of handling the A41 unit during this procedure, remove the torque converter and set aside. Temporarily install the A41 to check for tunnel clearance. Raise the installed transmission using the the transmission jack until the A41 is solidly contacting the tunnel. Measure the distance from centerline of tunnel to centerline of the A41 output shaft. If you have been successful with tunnel bumping, this measurement should be 2-1/2" or less.

Repeat the hammer bumping on the scratched paint contact areas and repaint the tunnel. Re-install the A41 and check for the 2-1/2" dimension again. It could take more than one iteration to achieve the required clearance. Once the 2-1/2" has been reached, the A41 installation process can be completed.

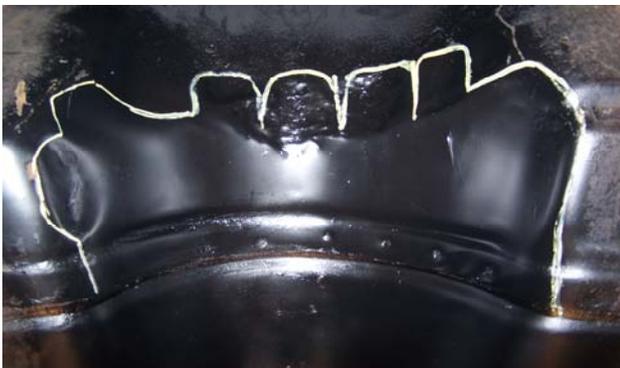
The following picture shows the completed tunnel with bumped areas. The original template outline is marked on tunnel.
